**Failure of an autopilot control cable,
stiffening of elevator control during flare**

Aircraft	Bombardier CRJ700 registered F-GRZN
Date and time	July 12, 2010 at around 18:30 UTC ⁽¹⁾
Operator	Brit Air
Place	Bilbao Airport (Spain)
Type of flight	Scheduled public transport of passengers
Persons on board	2 flight crew, 2 cabin crew 63 passengers, 2 babies
Consequences and damage	None

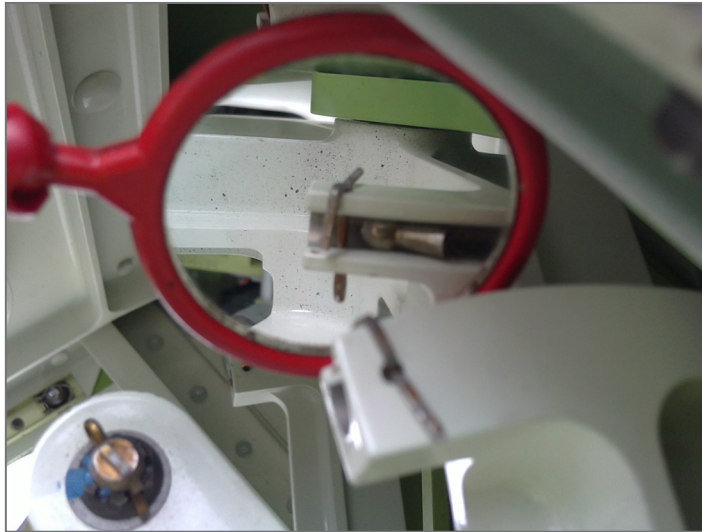
End of the broken cable, held in its housing in the quadrant, seen through a mirror

The failure occurred on the pitch-up cable, in line with the crimped cable end. The crimped cable end in its notch remained in the aft quadrant channel. However, it was observed that this end was incorrectly positioned – normally, the crimped cable end is also seated in the channel and cannot come out.

An examination of the failure showed that it resulted from progressive cracking due to fatigue. This mechanism began because of the incorrect assembly of the cable, which generated abnormal bending stress in line with from its crimped cable end.

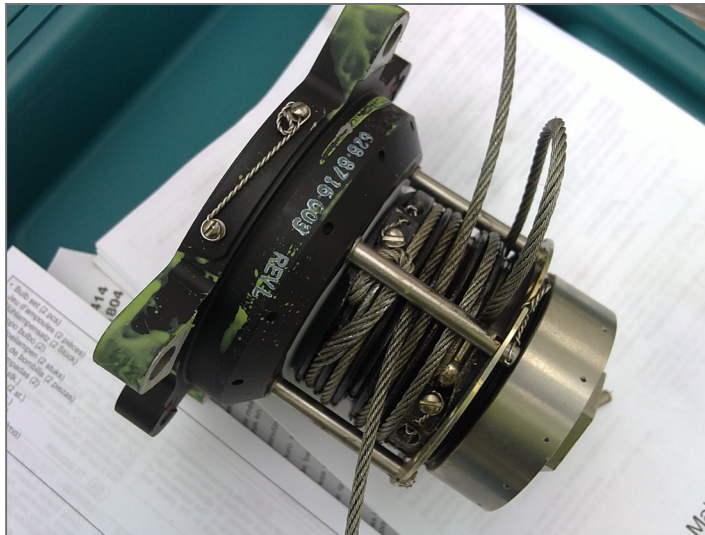
The maintenance operations performed following this incident revealed that the AP pitch-up elevator control cable was broken and that the free part of the cable, by forming a loop, had blocked the AP servo.

Loop formed by free part of cable that blocked the autopilot servo

The stiffening of the elevator was probably due to the blocking of the cable in the servo mechanism, whose consequence was to limit the travel of the elevator aft quadrant.

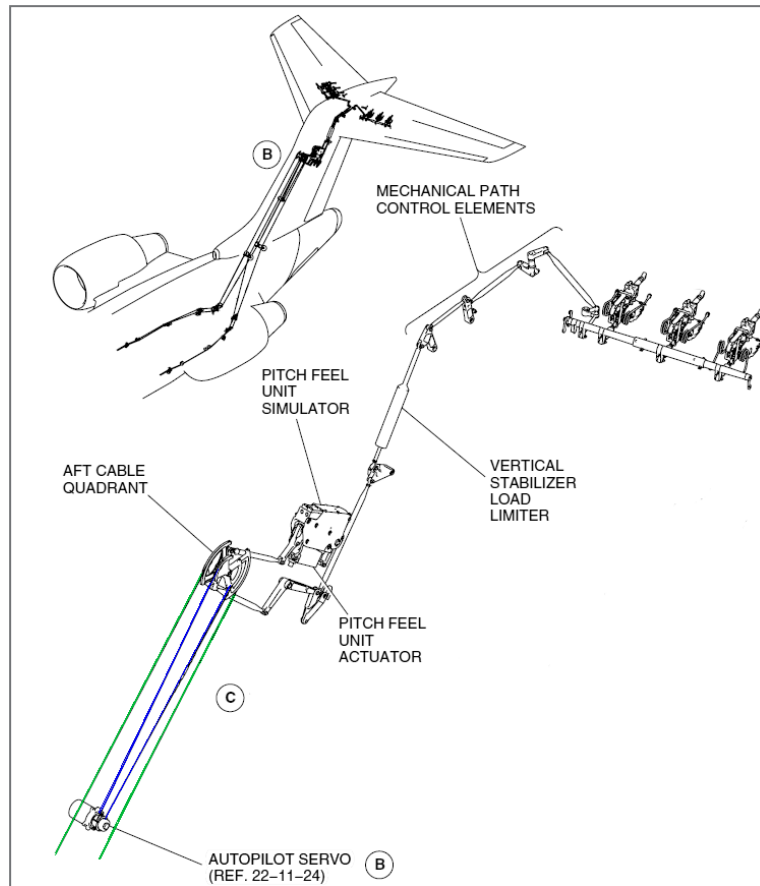
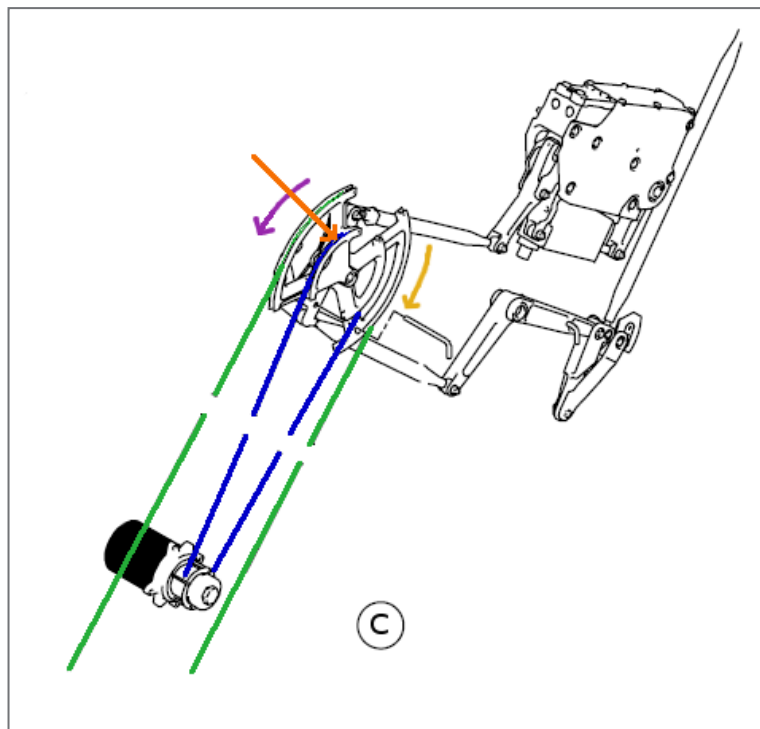
Diagrams of system (manual control path in green, automatic control path in blue; orange arrow indicates failure; yellow arrow indicates direction of rotation given to quadrant for an elevator pitch-down movement; purple arrow corresponds to a pitch-up movement)

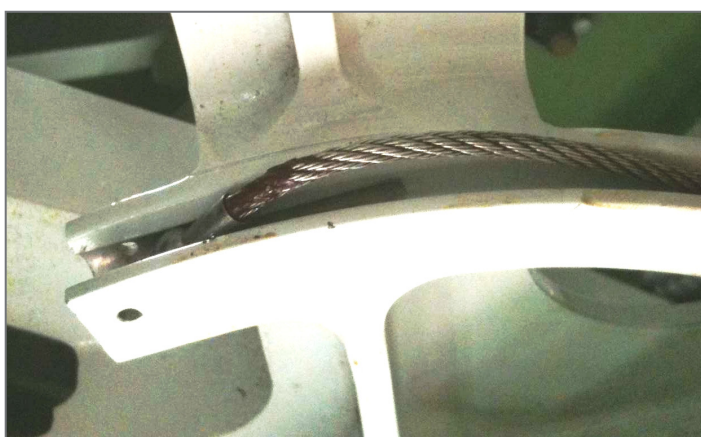
Example of incorrect assembly

The servo pitch-up command cable broke near the aft quadrant of the elevator due to fatigue, the result of incorrect installation of the end of this cable in the quadrant channel. This incorrect installation most probably occurred during assembly of the elevator at the time of aircraft construction.

- Revised AMM Task 22-11-24-710-801;
- Revised Bombardier “Functional Test Procedure”;
- Revised Aeronova “Cahier de Montage”.

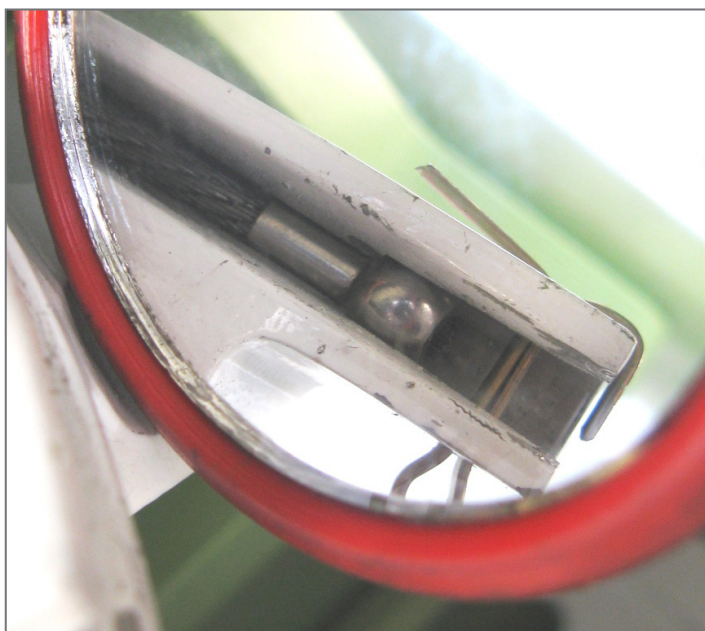
Example of correct assembly

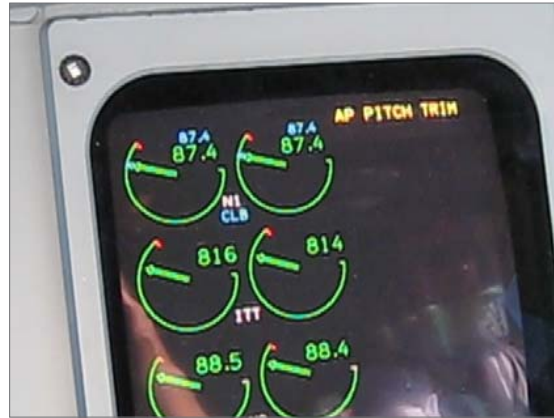
This was useful because it allowed the display of the "AP PITCH TRIM" caution message on EICAS during the flight to be identified with certainty, compensating for the inadequate information provided by the flight recorders. In fact, the flight recorders indicated the triggering of a caution message but did not specify which message was displayed by the EICAS. An in-depth study based on the other parameters and on the knowledge of aircraft systems could have allowed assumptions to be made regarding the origin of the caution message but would probably not have confirmed this absolutely.

Image extracted from video provided by crew
